Monitoring of a Historical Masonry Structure in Case of Induced Seismicity

Ihsan Engin Bal, Dimitris Dais, Eleni Smyrou & Vasilis Sarhosis

^aResearch Center for Built Environment NoorderRuimte, Hanze University of Applied Sciences, Groningen, The Netherlands; ^bSchool of Civil Engineering, University of Leeds, Leeds, UK

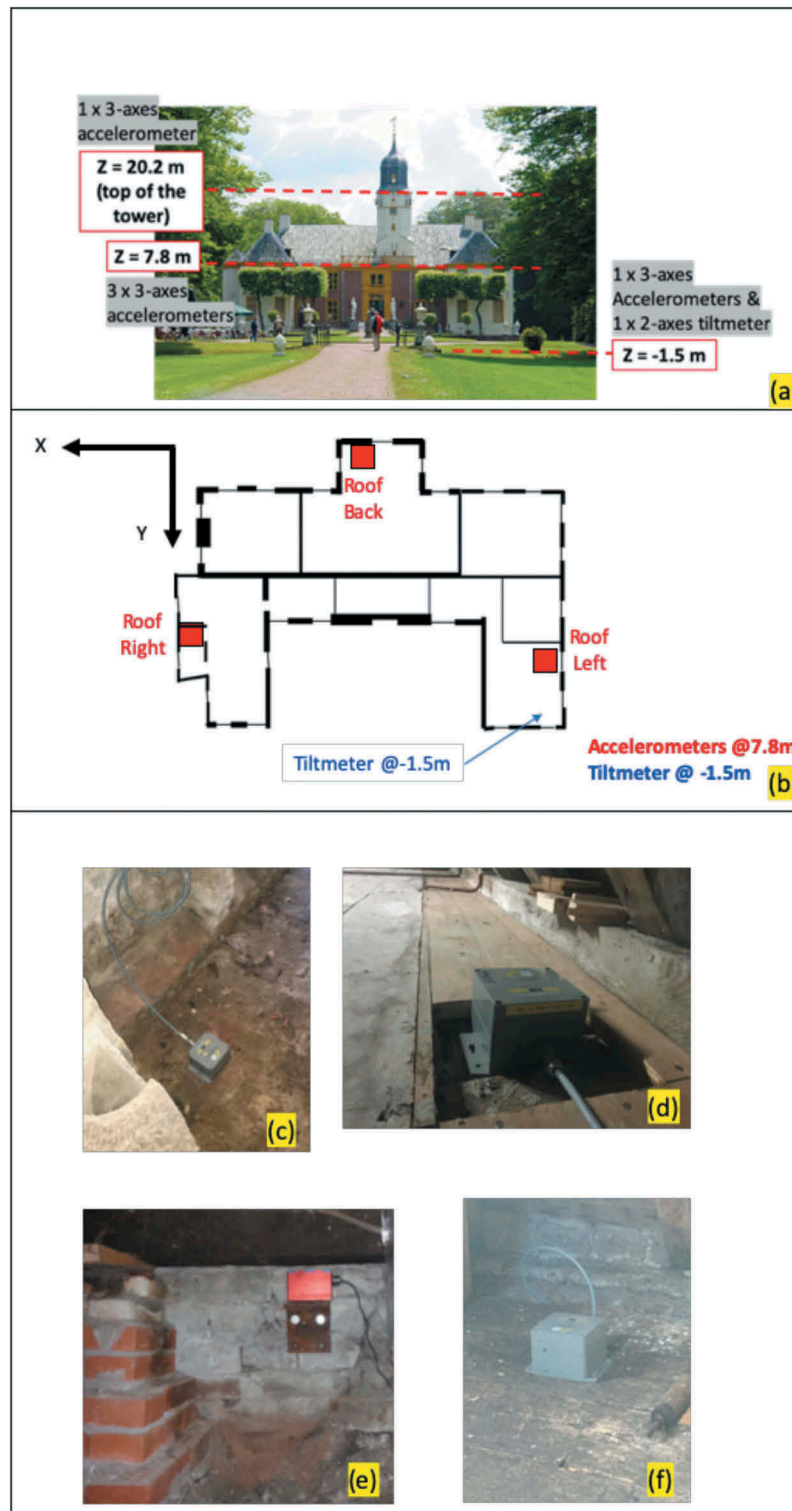
Figure 6. (a) Elevation of the sensor locations, (b) Sign convention for the accelerometers and the tiltmeter sensor, (c) Accelerometer at the basement, (d) Accelerometer on top of the bearing walls at 7.8 m elevation, (e) Tiltmeter at the basement, and (f) Accelerometer on the tower floor.

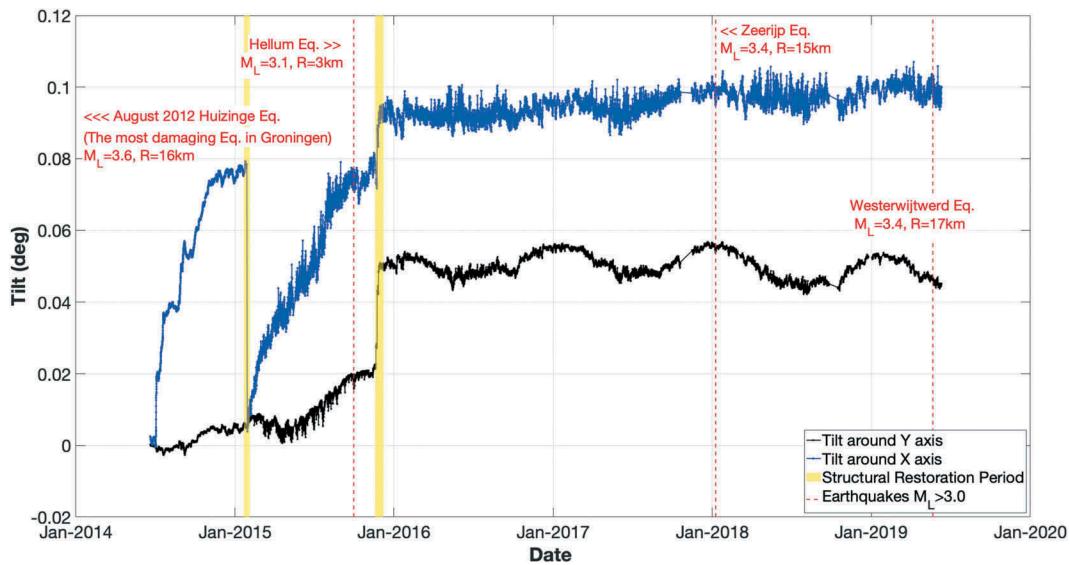
Figure 7. Tiltmeter measurements since 2014, together with significant earthquakes and restoration periods.

the tilt values around both axes. The data jumps around the restoration periods are because of this. In overall, it is evident since the beginning of the monitoring (sometime mid-2014) until the end of the structural restoration and repair (beginning of 2016) that the tilt values systematically increased with the exception of the major structural restoration period that took place right after the Hellum Earthquake of ML 3.1 that occurred just 3 km from the structure. Furthermore, the significant earthquakes (magnitude above 3) recorded during the monitoring period do not present evident effects on the overall plot; however, this may be because the changes in tilt during or after these earthquakes are not big enough and remain concealed by the temporal changes and noise of the tilt measurements. Thus, as explained in detail later, the evaluation of the structural response to each event needs to be done individually. Finally, it is also observed (Figure 7) that the tilt around Y-axis is stabilized around a virtual baseline after the restoration and repair works, as only fluctuations for the seasonal changes can be observed after that date. On the contrary, the tilt around X-axis exhibits an increasing trend since the end of the restoration and repair works.

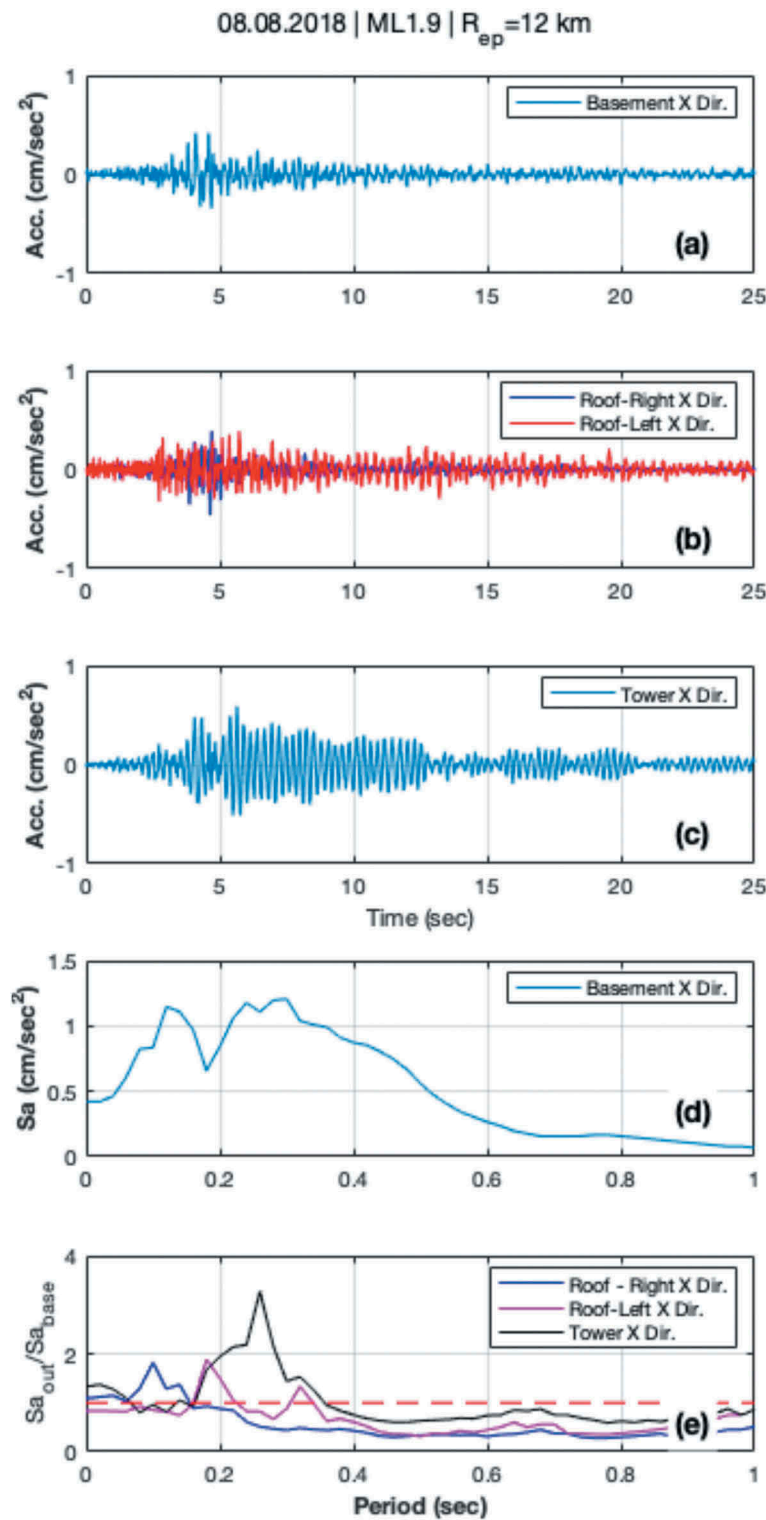
are baseline corrected and bandpass Butterworth filtered between 0.1 and 20 Hz. The motion was detected by the sensors although the maximum accelerations do not exceed 1 cm/sec^2 (0.001 g). The tower amplified the input

motion approximately 3 times, while the structure itself amplified it 2 times, both still remaining well below the horizontal acceleration levels that would normally cause any cracks.

Figure 8. For the 8th of August 2018 Appingedam Earthquake of ML 1.9 in epicentral distance of 12 km are presented: acceleration time-histories (Acc.) in the X direction for the sensors at (a) The basement level, (b) The roof level (right and left side of the structure, shown in Figure 6b), and (c) The tower, (d) 5% damped spectral acceleration (Sa) as obtained from the sensor at the basement in the X direction, and (e) transfer functions (spectral acceleration on the structure (Sa_{out}) divided by the spectral acceleration at the base (Sa_{base})).

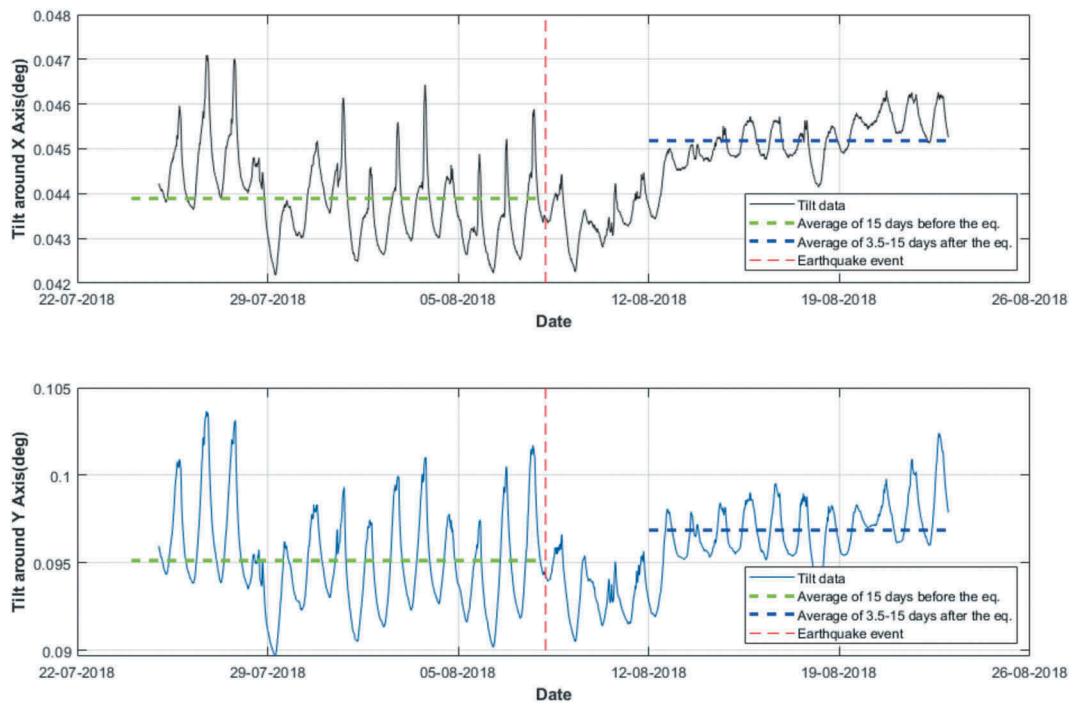
During the seismic excitation, the fluctuation of tilt recorded was rather insignificant. Thus, only examining real-time tilt data would not offer an insight into the degree of damage that actually led to the formation of new cracks. In order to better understand the cause of damage, low sampling rate tiltmeter data have also been examined (Figure 9). For the last 15 days before the earthquake, the daily temperature cycles oscillate on average around a baseline but the motion builds up in a way in the three days following the earthquake. From the 4th to 15th day after the earthquake, tilt values in both axes increase significantly jumping to a new baseline. Furthermore, the range of angles in daily temperature changes also decreases causing the tilt values to fluctuate in a narrower band. A new baseline of tilt values indirectly signifies a certain level of plastic deformation, indicating that damage took place.

Figure 9. Low sampling rate tiltmeter data 15 days before and 15 days after the earthquake of 08.08.2018 Appingedam (ML 1.9).

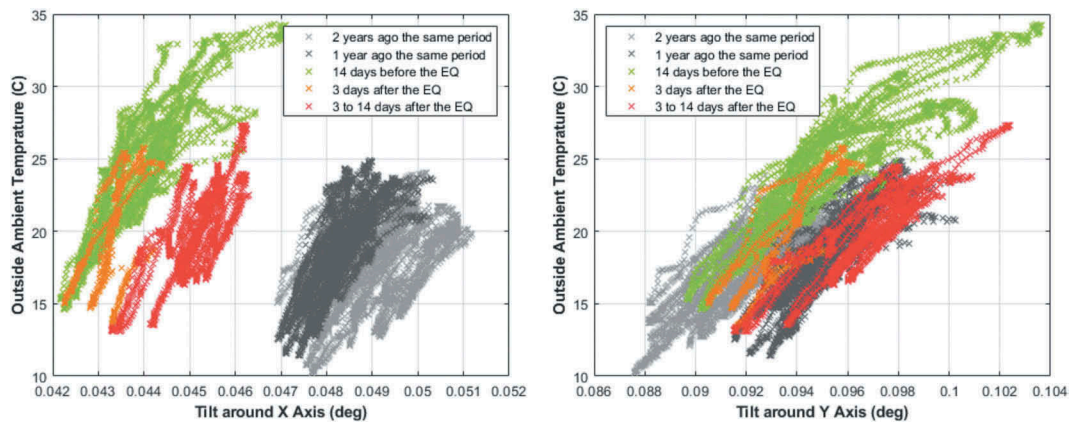
It is naturally expected that the tilt values are highly influenced by the temperature changes. In order to decouple the temperature effects from the measurements, plots in Figure 10 were prepared where the 30-day period (15 days before and 15 days after the earthquake) has been plotted against the measured ambient temperature. Furthermore, in order to understand the progress of the tilt, the exact same 30-day periods are also plotted for one and two years before (2017 and 2016 respectively) for the same period of the year. These data are used to understand the relevance of the observed damages with the Appingedam Earthquake of ML 1.9. The first and striking observation is that the

Figure 10. Tilt angles recorded ± 15 days from the earthquake and last two years before.

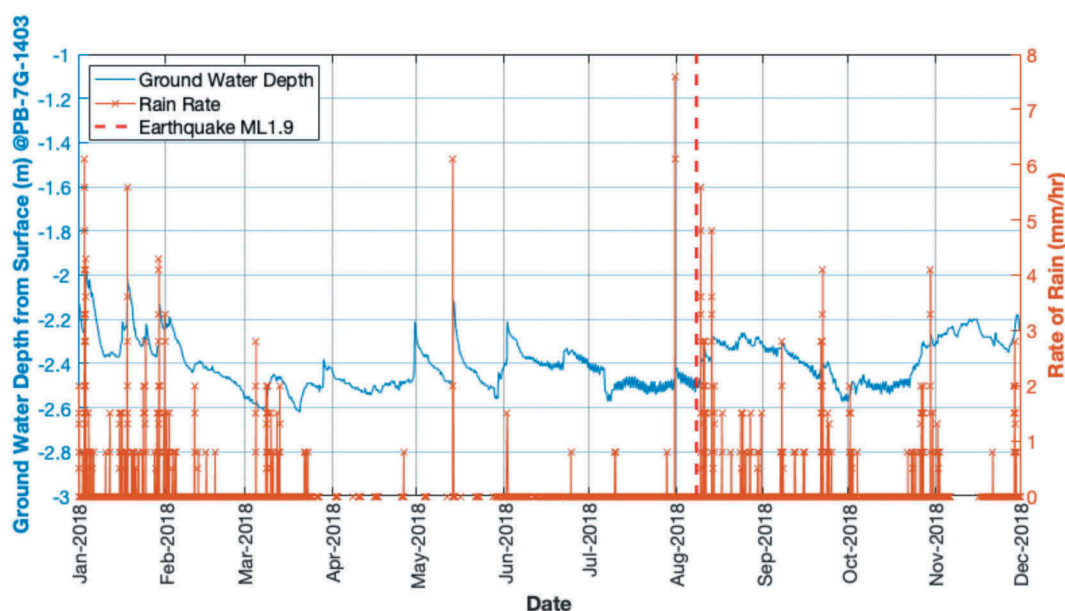
Figure 11 reveals a very dry period from mid-March to mid-August in 2018, reported as a disastrous period for the farmers in the region due to the extremely dry soil. It was also witnessed in soil drilling works that the

clay layers were hard and dry due to lack of rain for a very long period. As seen in Figure 11 the start of the rainy period coincides with the earthquake (in fact, a couple of days later). When other rainy periods in the data are examined, tiltmeter data are found mostly insensitive to the rain. Furthermore, the out-of-the-ordinary movement (i.e. change in tilt baseline) in the tiltmeter data starts right after the earthquake, proving that the movement is related to the earthquake motion too.

Figure 11. Ground water depth from the surface and the rate of rain in 2018 in the monitoring well 600 m south of the site.

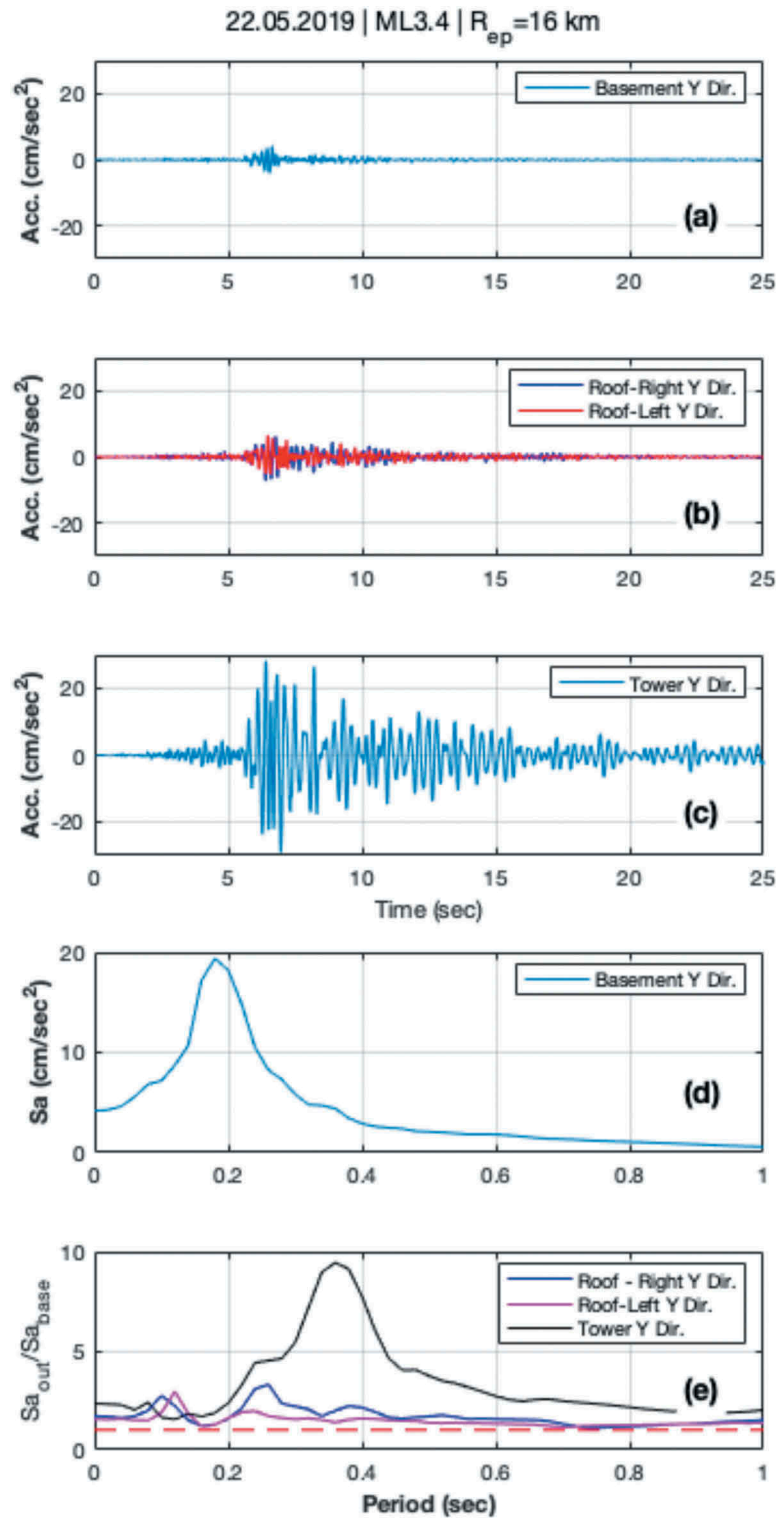
If the monitoring results constituted merely by acceleration measurements, one could argue that the structure should have had much more cracks after the 22nd of May 2019 earthquake of ML 3.4 since the accelerations at the base, on the structure and at the tower were much higher than the respective of the event in the 8th of August 2018 (Bal and Smyrou 2019a). Note that the

horizontal PGA at the basement was 0.004 g and the maximum absolute horizontal acceleration at the tower was recorded as 0.03 g. Although still very small, these accelerations are larger, more than an order of magnitude, as compared to the acceleration levels of the August 2018 event (Figure 12). A detailed check on the photographs of the crack rulers showed that no significant movement took place during the May 2019 earthquake. When the tilt data of 15 days before and 15 days after were examined, no change of tilt baseline or any other out-of-the-ordinary movement was observed. Had the seismic SHM system relied only on the accelerometer data, the fact that the August 2018 earthquake caused damages, while the stronger (in terms of acceleration) May 2019 earthquake caused no damage, would be inexplicable.

Figure 12. For the 22nd of May 2019 Westerwijrtwerd Earthquake of ML 3.4 in epicentral distance of 16 km are presented: acceleration time-histories (Acc.) in the Y direction for the sensors at (a) The basement level, (b) The roof level (right and left side of the structure, shown in Figure 6b), and (c) The tower, (d) 5% damped spectral acceleration (S_a) as obtained from the sensor at the basement in the Y direction, and (e) Transfer functions (spectral acceleration on the structure ($S_{a_{out}}$) divided by the spectral acceleration at the base ($S_{a_{base}}$)).
